Mobile Intel[®] Pentium[®] II Processor Specification Update

Release Date: April 2006

Order Number: 243887-052

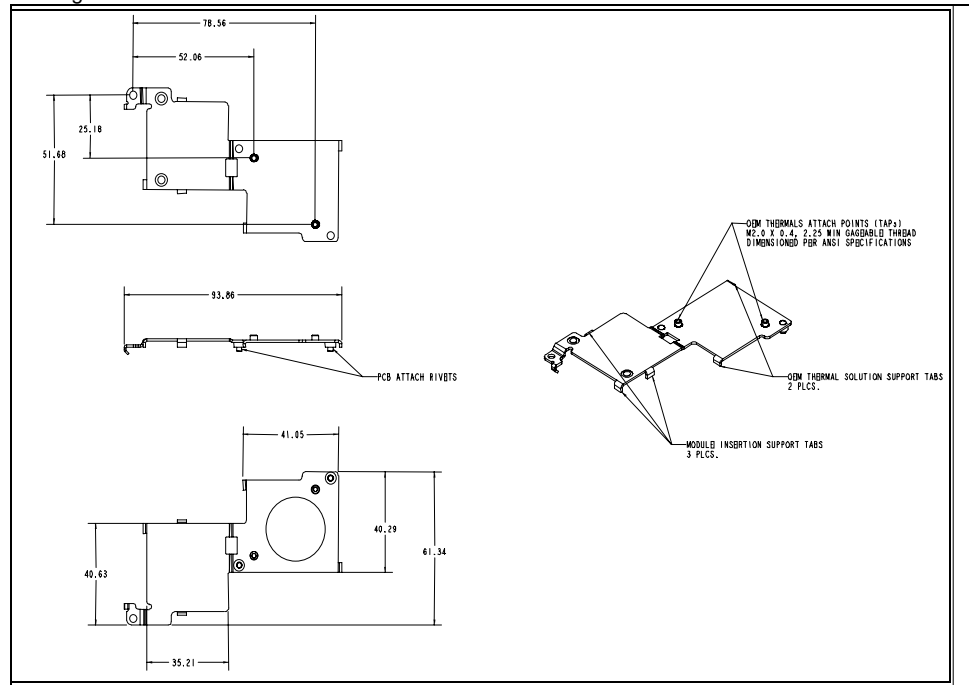
Figure 1. TAP Gageable Thread Clarification

OEM Thermal Attach Points (TAPs) M2.0 x 0.4, 2.25 min gageable thread dimensioned per ANSI specification.

See Figure 1 below for more information.
